# CUSTOMER CASE STUDY

Data Centers

5 Chiller Plants (~500,000 gals system volume & 6,700 tons of cooling capacity)

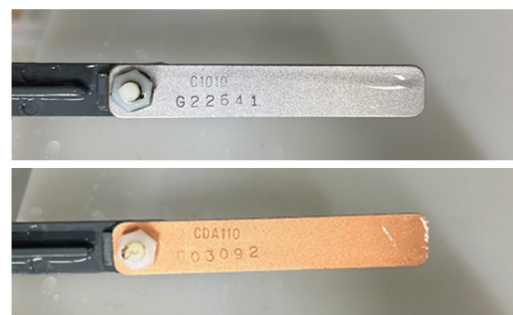
Coupons from corrosion study after treatment with EcoSHIELD

Average **0.87 MPY** Mild Steel

Average **0.17 MPY** Copper
